## Hydrographic Survey For Irrigation Pond Evaluation

### Surveying Engineering Capstone Project

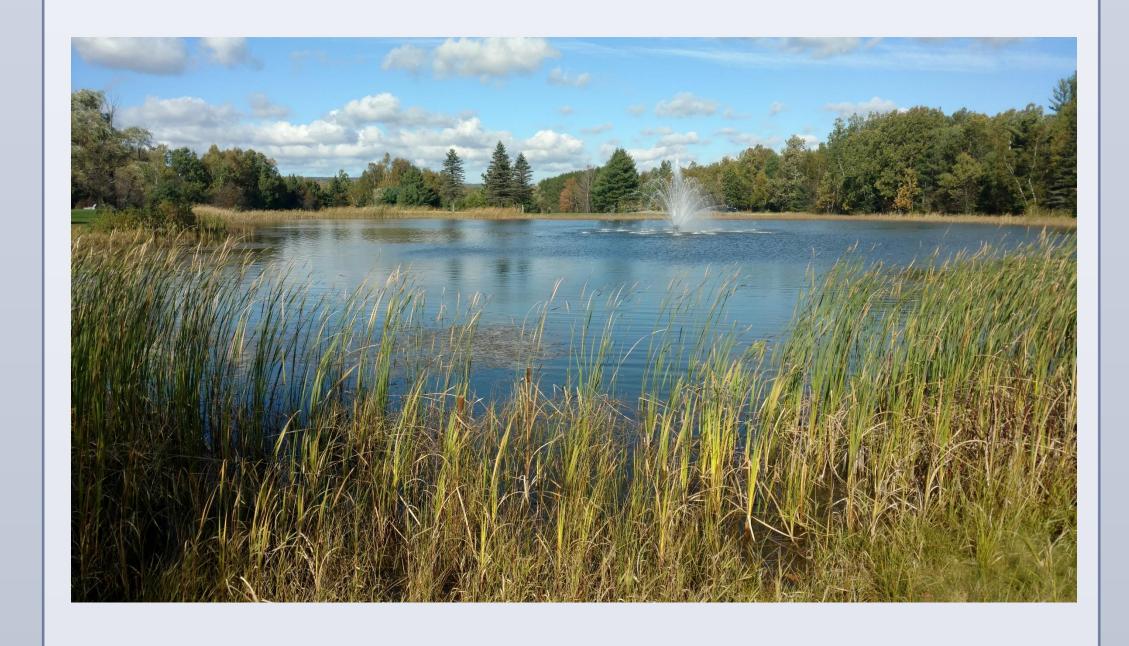
After reviewing the limited water bodies residing on golf course property within the Keweenaw, a pond was discovered at the Portage Lake Golf Course (above). This location was ideal for two reasons: The pond area was deemed small enough to survey the entire bottom, while relying on limited experience, and there were no immediate obstructions that could interfere with GNSS measurements of the surrounding grounds. The course's manager was contacted and the project team was granted full access.

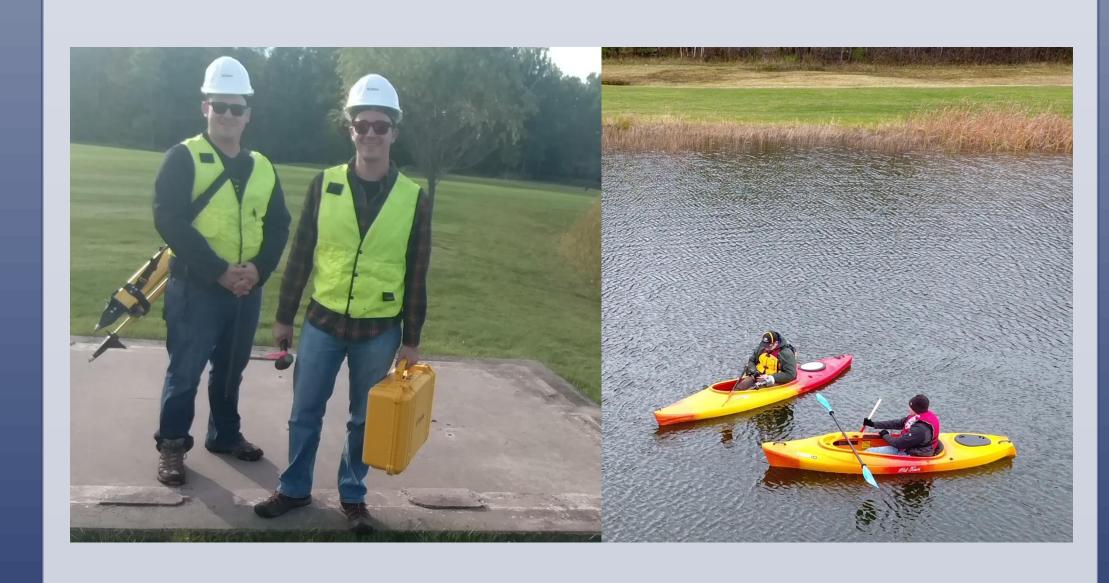
Safety was the team's first concern. Motorized cart drivers needing to be aware of the surveyors' presence and stray golf balls were identified as the primary issues. It was determined that safety vests and hardhats were necessary to mitigate these concerns (below left). There was also a small, concrete block, weather shelter adjacent to the primary work area. This shelter served as a safety solution to inclement weather and acted as a shield from opposing tee offs. The course closed for the season on October 16<sup>th</sup>, nullifying the initial safety precautions and the safety vests and hard hats were discarded for the remaining portion of the project. An additional safety consideration became a factor near the conclusion of the field work: kayaks needed to be taken out on the pond during cold weather. To do this safely, properly rated life jackets were worn (below right), a heated vehicle was kept nearby and a volunteer was stationed on shore for help in the event of an accident.

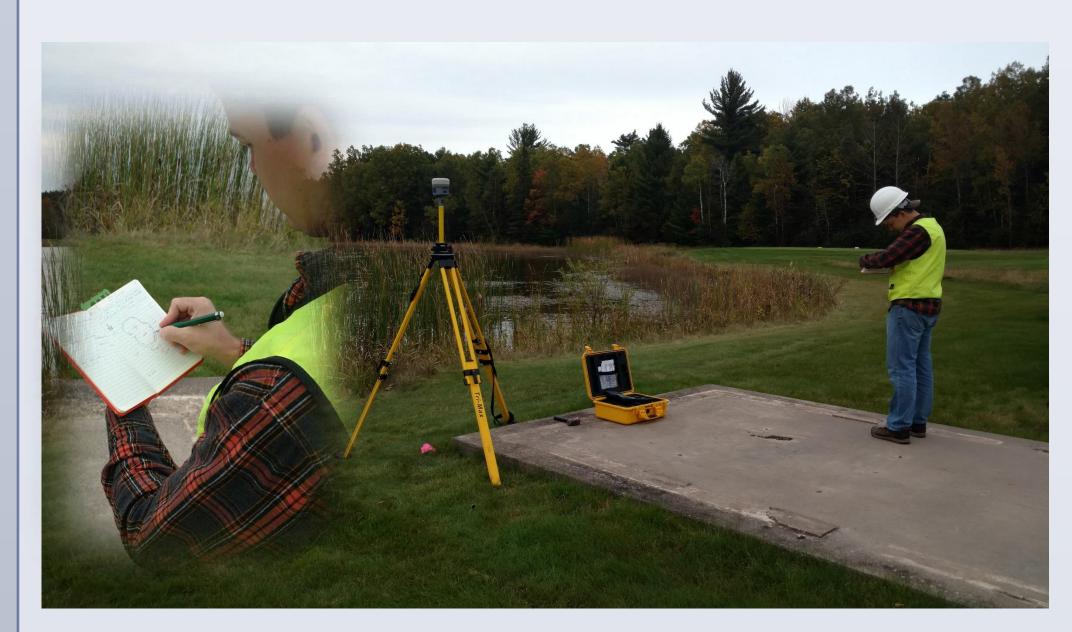
After the reconnaissance, it was determined that the control point would work best near the corner of a concrete pad. This would help protect the control from being disturbed by activity such as mowing and also minimally impact the cultivated turf. A half-inch rebar was set and immediately occupied for the first of two separate static sessions

To use RTK for the data collection, a local GNSS control point would need to be set and used for a base station. A visit to the site allowed an acceptable location to be identified and provided insight into how future fieldwork would best be performed.

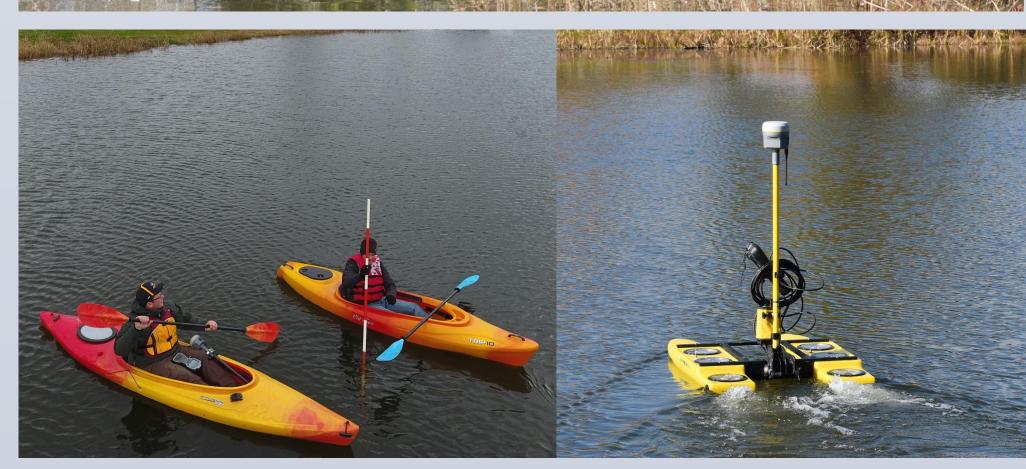
The topographic data collection was performed with a Trimble R10 and a TSC3 data collector. All features within fifty feet of the edge of water were collected including trees, structures, and ground shots. The bathymetric data collection was completed with a Hydrone ROV, Sonarmite Echosounder, Trimble R10, and Trimble TSC3 data collector. The ROV was piloted in multiple grids across the pond. After collecting data for a short time, the survey was stopped briefly to ensure everything was working properly. Far more data was collected than necessary in order to guarantee there would be no need for a return trip with the Hydrone. Manual checks were performed with range poles and a selection of the sonar points for stakeout. The checks were found to be consistent with the collected data.
